Degradation of concentrating solar thermal reflectors in acid rain atmospheres

A. García-Segura^{a,*}, A. Fernández-García^a, M.J. Ariza^b, F. Sutter^c, L. Valenzuela^a

^aCIEMAT, Plataforma Solar de Almería, Ctra. Senés, km 4, P.O. Box 22, 04200 Tabernas, Almería, Spain

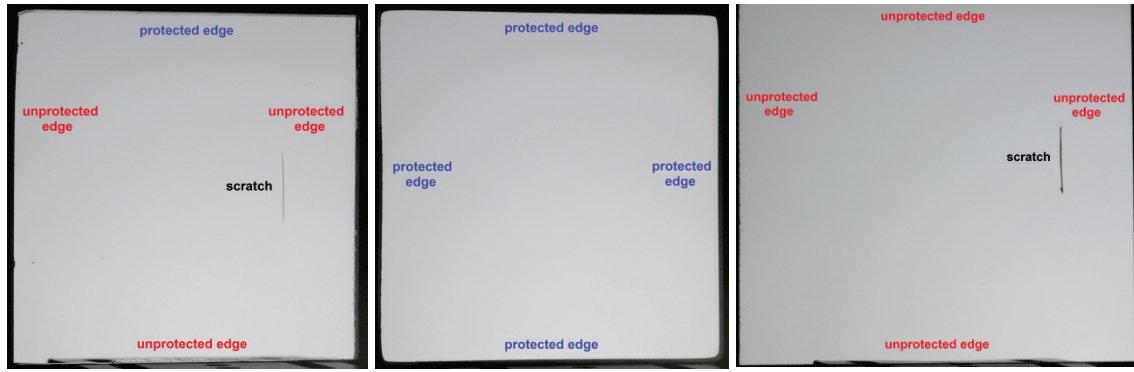
As seen in Fig. 1left, Type 1 silvered-glass samples are the most unfavorable case of silver exposed to the corrosive environment, because all three have unprotected cut edges and a 2-cm-long scratch in the paint on the back. In contrast, the silver in Type 2 silvered-glass reflectors (Fig. 1center) is less exposed, since they were specifically manufactured to a 10x10 cm² format specification with four original, protected edges and no deliberate damage. Therefore, Type 1 reflectors are referred to as predamaged silvered-glass reflectors and Type 2 as undamaged silvered-glass reflectors. Both Type 1 and Type 2 samples were produced by the same commercial silvered-glass reflector manufacturer. Edges are not protected in aluminum reflectors for real applications, and so first-surface aluminum reflectors (Fig. 1right) include both unprotected edges and a 2-cm scratch on the front, to expose the reflective layer to the corrosive atmosphere. The main features of the reflector materials studied are summarized in Table 1.

Fig. 1. Solar reflector samples weathered in the corrosion experiments: Type 1, predamaged silvered-glass reflector (left), Type 2, undamaged silvered-glass reflector (center), and Type 3, predamaged aluminum reflector (right). The protected edges are marked in blue, unprotected edges in red and the scratch in black.

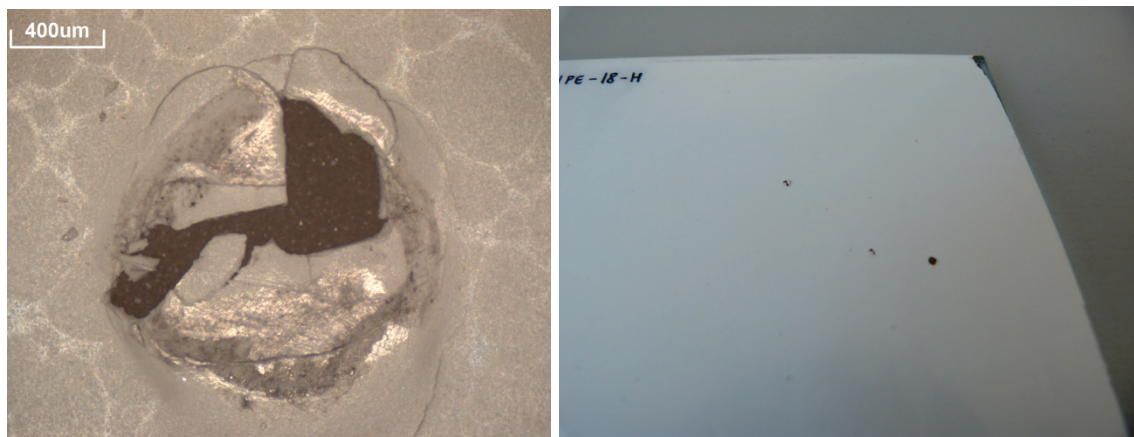
Although the tests with no gas (K_0_25, K_0_40 and K_0_50) did not cause any significant degradation on the reflective layer of Type 1 reflector materials, these humidity tests do promote occasional blistering of the paint on the back, as shown in Fig. 4. Such blisters might not be easy to detect in the gas tests because they are prone to flaking off and leaving pinholes as a result of the high severity of the Kesternich tests [40]. Even though not all corrosion spots

Fig. 4. Microscope image of a paint blister on the back of a Type 1 silvered-glass reflector sample taken at 5x magnification after 20 cycles of the K_0_40 humidity test (left), un magnified image of blisters (right).

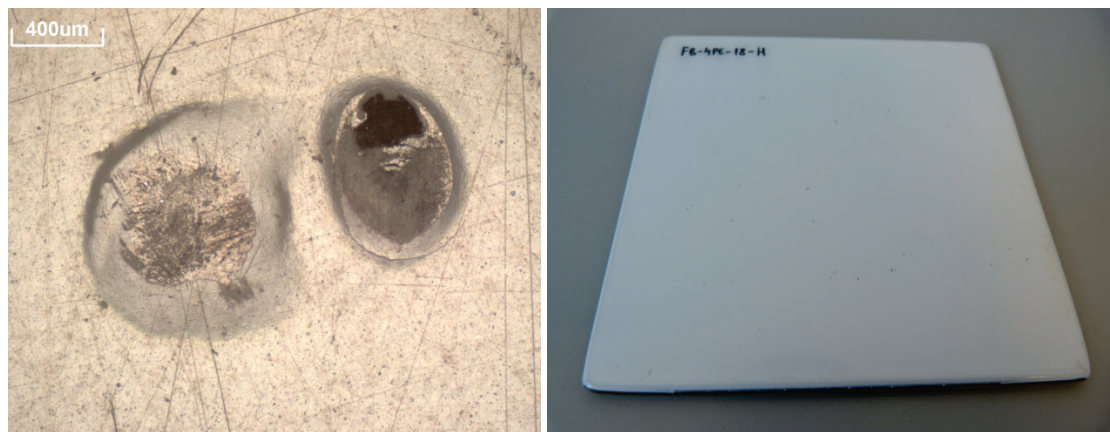
Fig. 8. 5x microscope image of blisters found in the paint on the back of a Type 2 silvered-glass reflector sample after 20 cycles of the K_0_40 humidity test (left), picture of the appearance of blisters at naked eye (right).

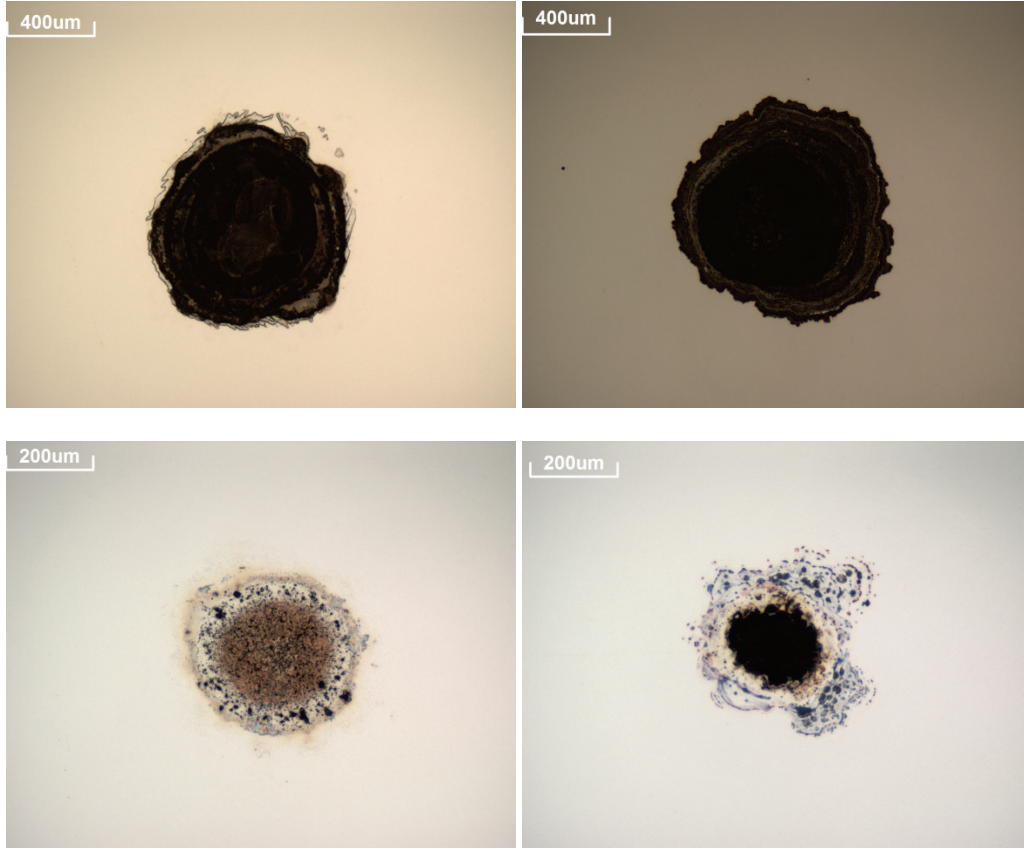
The most informative and aggressive test (K_2_40) was compared to real data from corroded mirror facets at a commercial CSP plant near an industrial site[†]. After three years of exposure at this site, the PTC facets were inspected, and a mean pitting corrosion area of 0.16% was estimated. Both the Type 1 silvered-glass reflectors and the samples from this commercial CSP plant were from industrial PTC facets made by the same manufacturer and have the same layered structure. Indeed, corrosion spots found on Type 1 silvered-glass reflectors were very similar to the on-site facets, as shown in Fig. 12. Type 2 silvered-glass reflectors, however, although by the same manufacturer, were specifically manufactured at small scale in a $10 \times 10 \text{ cm}^2$ format, and hence, these results are not comparable.

Fig. 12. Microscope images of corrosion spots on Type 1 silvered-glass reflectors in on-site PTC facets after 20 cycles of Test K_2_40 (left) and after three years at a commercial CSP plant near an industrial site (right).

In addition, results from Test K_2_40 were compared to corrosion data from real on-site PTC facets located near an industrial environment. Microscopic defects found in Type 1 silvered-glass reflectors were very similar to corrosion spots in the on-site facets. An estimated acceleration factor of 57 correlates Test K_2_40 with this real outdoor exposure affected by a highly polluted industrial atmosphere. This may be considered a valuable contribution to the service lifetime prediction of solar reflector materials, especially the widely deployed silvered-glass reflectors.
